Company: Borucao Ingeniería & Arquitectura
Contact: Ing Gloriana Ouellette
Phone: 85797171
Email: glorianao@borucao.com

Title: 03/03/2026
Group: Tanque de Asada - Reparación
Created: Tue, 3/3/2026
No. Items: 5

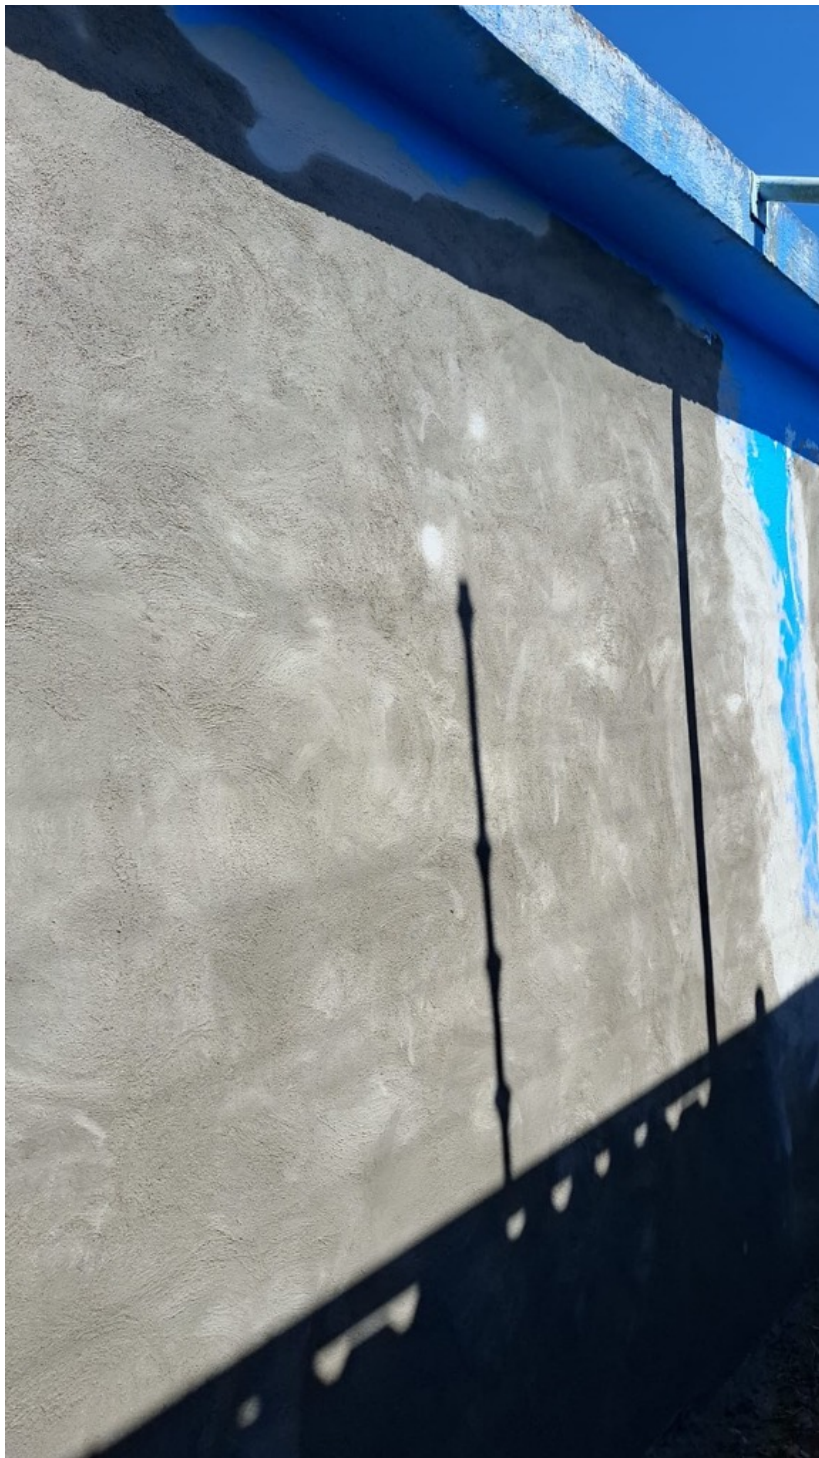
(1)

Maxistick + Maxipatch

Colocacion de maxistick en las fisuras de 0.5cm y colocacion de 0.5cm de espesor en paredes externas

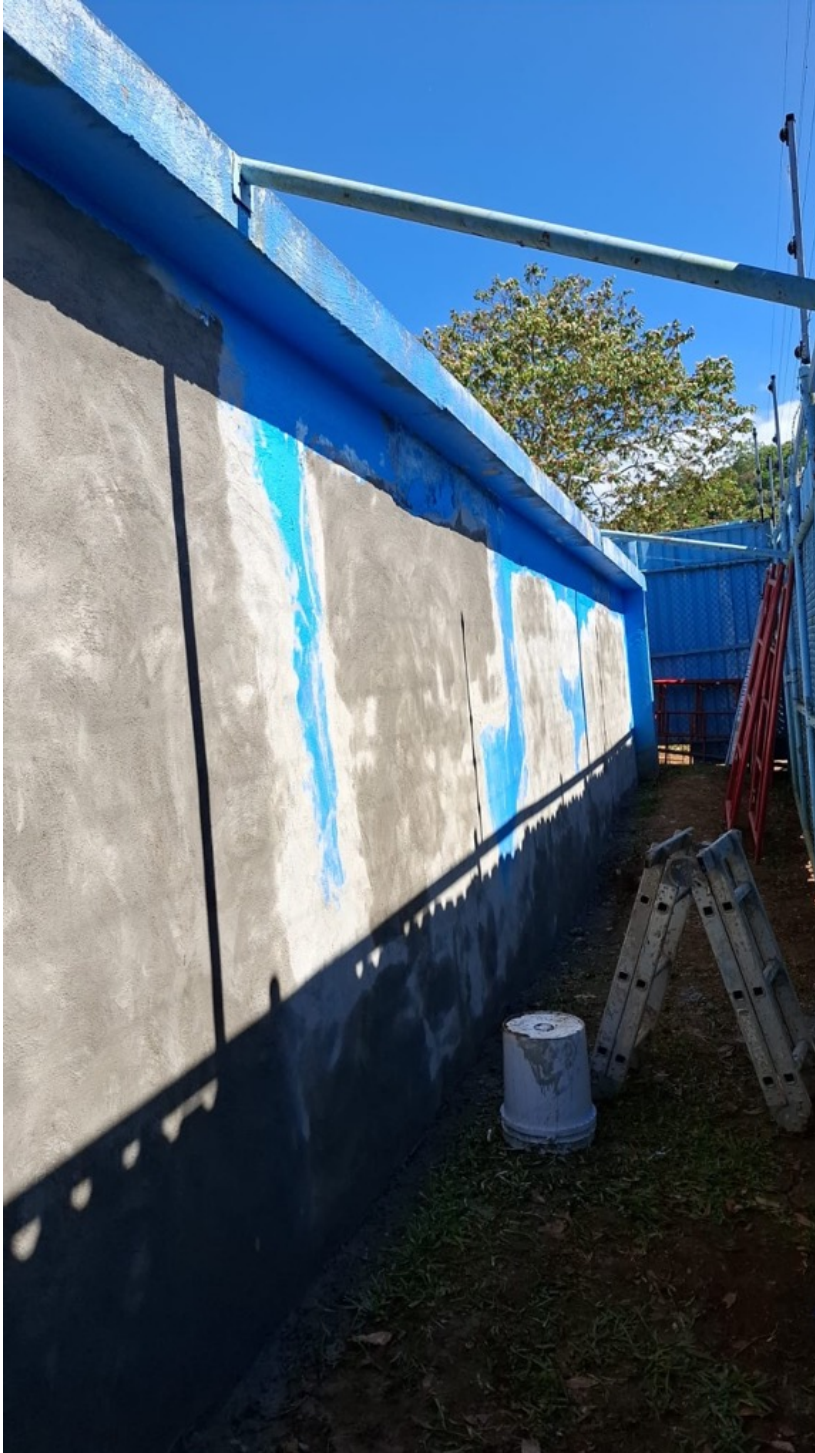
(2)

Maxistick + Maxipatch

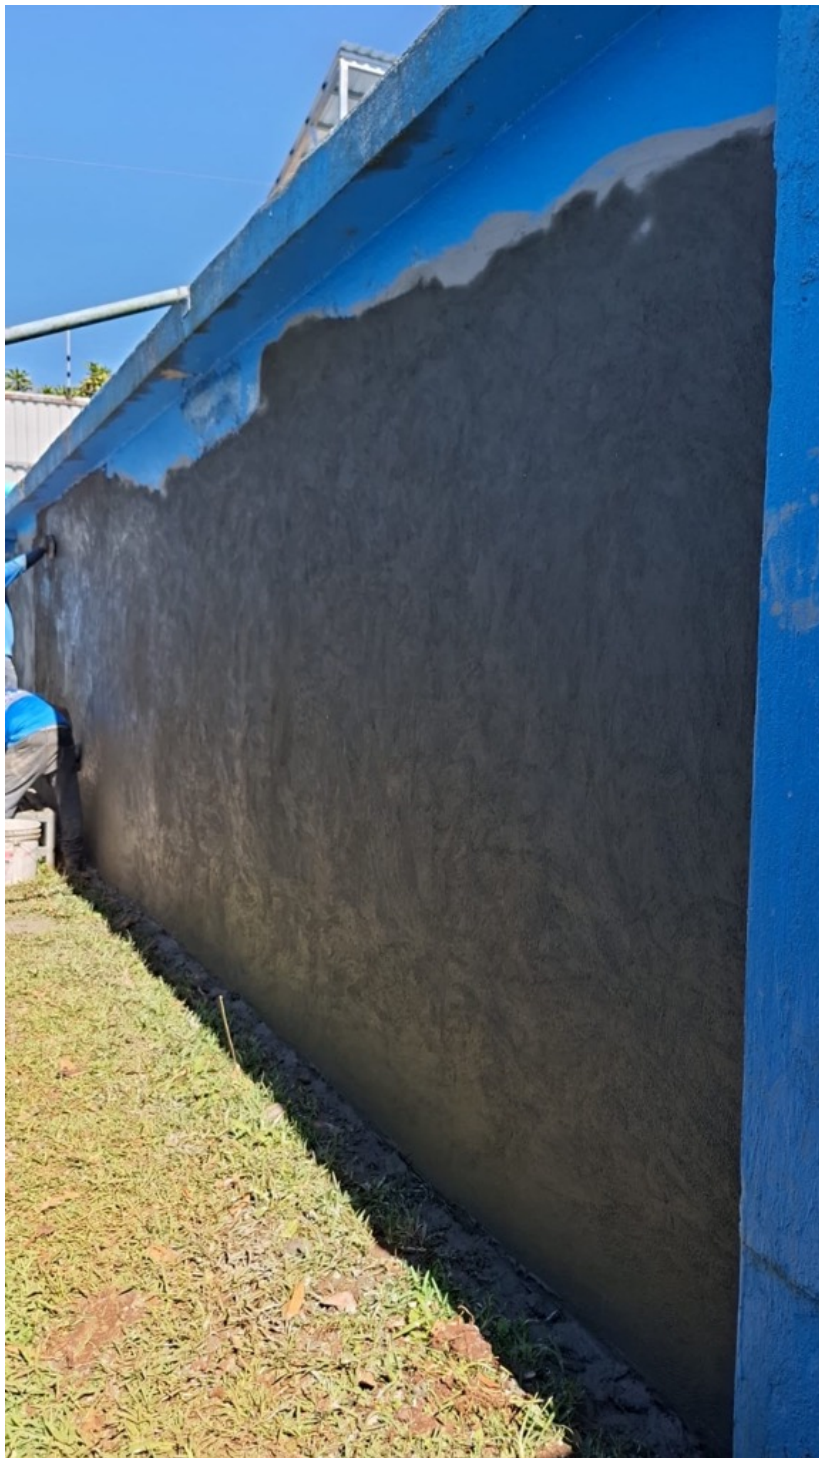
(3)

Maxistick + Maxipatch

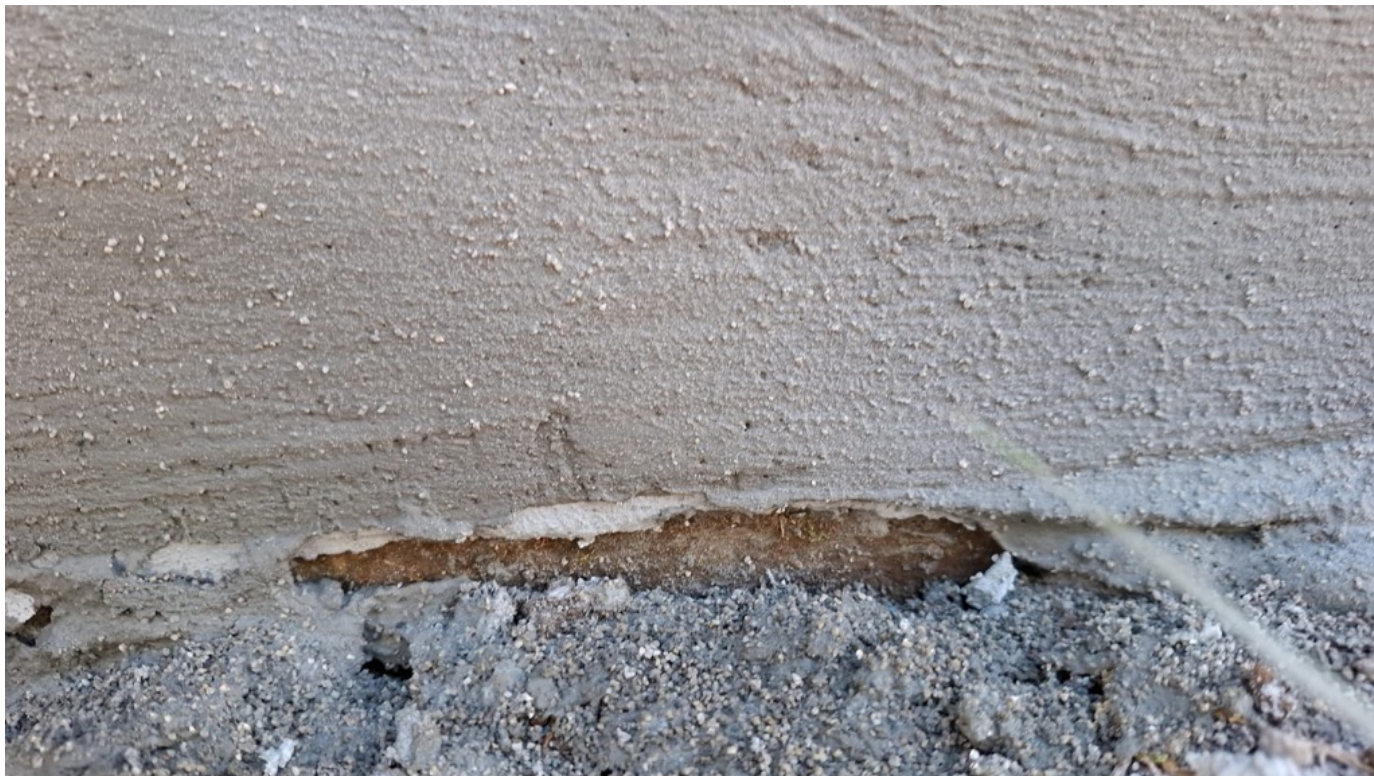
(4)

Maxistick + Maxipatch

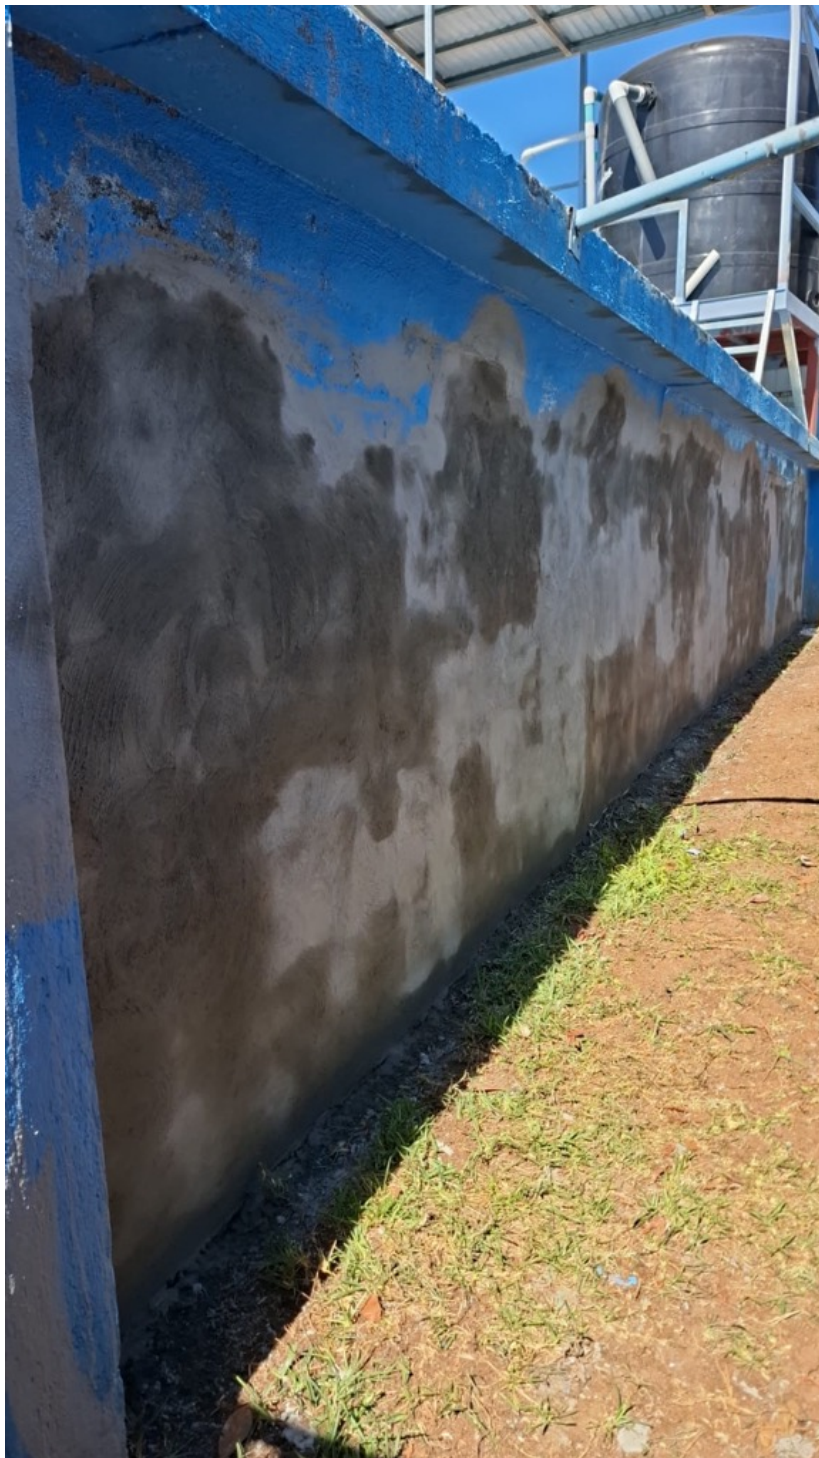
(5)

Maxistick + Maxipatch
